Technical Memorandum 21-80

AN INVESTIGATION OF THE FIVE POINT RESTRAINT
SYSTEM FOR AVIATORS

William B. DeBellis

October 1980

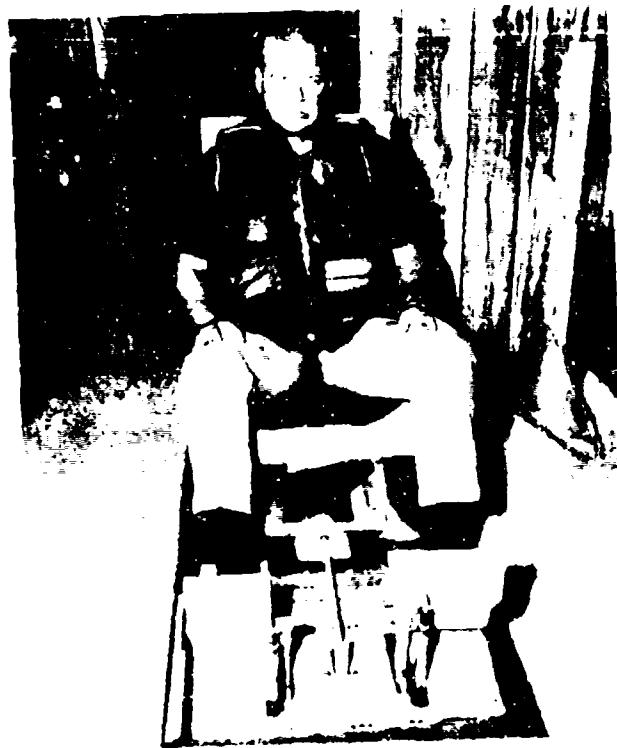
Figure 12. Subject MF, front view, aft anchor location.

Figures 9 through 14 show at least three variations on how the shoulder straps were positioned by the subjects over the survival vest. Subject MF (Figure 10) positioned the straps outboard to keep the straps from chafing his neck as seen in Figure 12. Figure 10 also shows the straps riding over the survival radio and first aid kit which could become damaged under high "G" loading because they were sandwiched between the subject's torso and the straps. A loose crotch strap may allow the subject to move placing increased pressure on the gear.

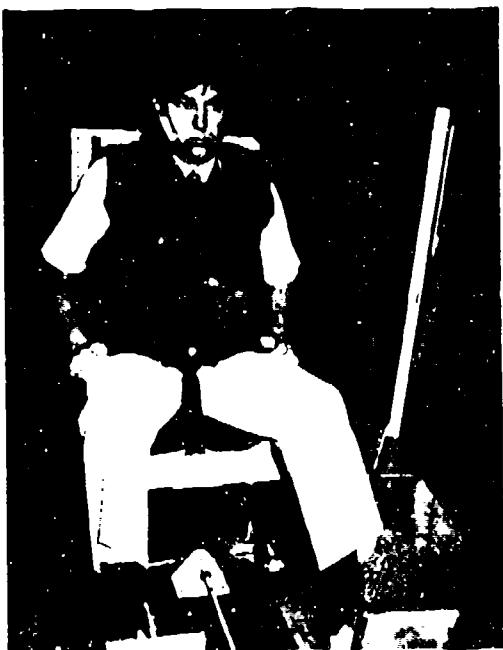
Figure 14. Subject CF, front view, aft anchor location.

Figure 14 shows the straps inboard of the survival vest gear with the straps bearing on the subject's neck.

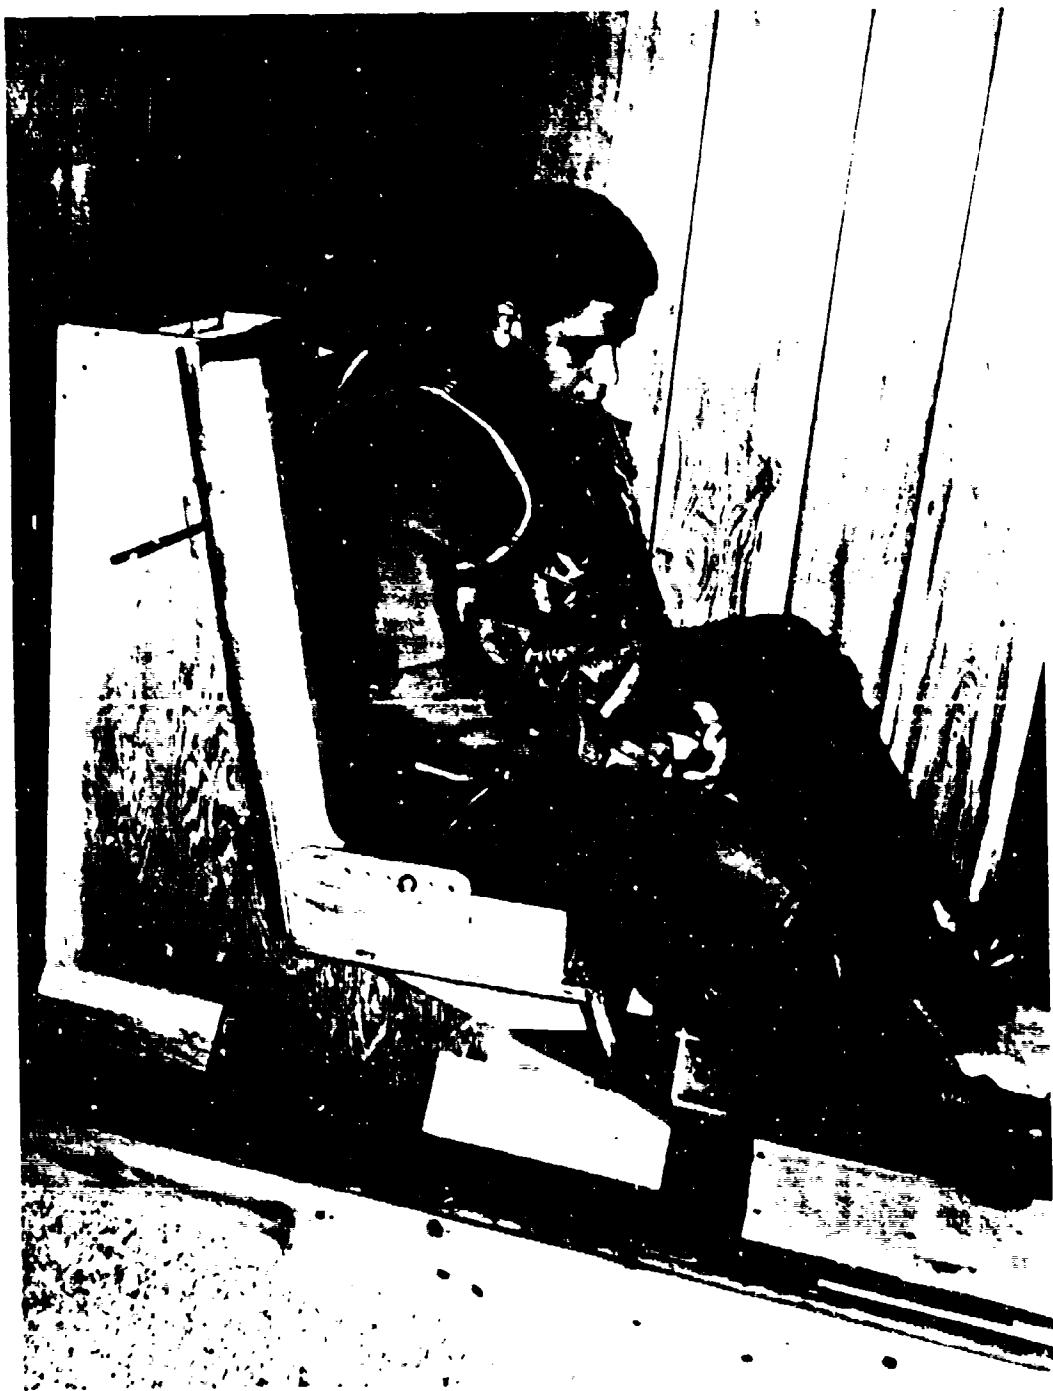
Several subjects had difficulty inserting the attaching spades while wearing the body armor and survival vest because they could not see the release mechanism (see Figure 17).

Figure 17. Vision restriction.
